# Manhole Inspection Summary

Manhole # S21WW1127MH

**Location** Address: **20 ROLAND GREEN**

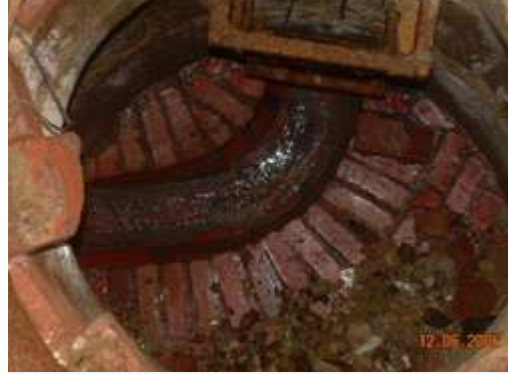
Top View

Adjustment deterioration, loose brick, root intrusion and infiltration. Corbel and Barrel infiltration. Bench debris.

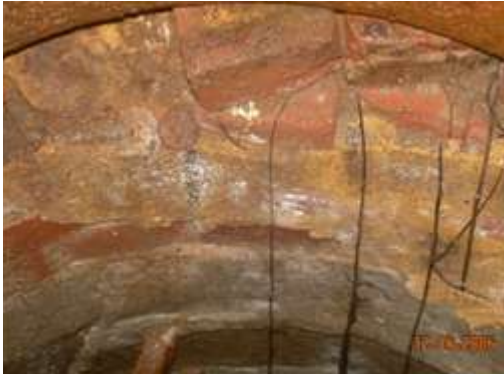
Defect

Frame leaks. Adjustment root intrusion and infiltration.

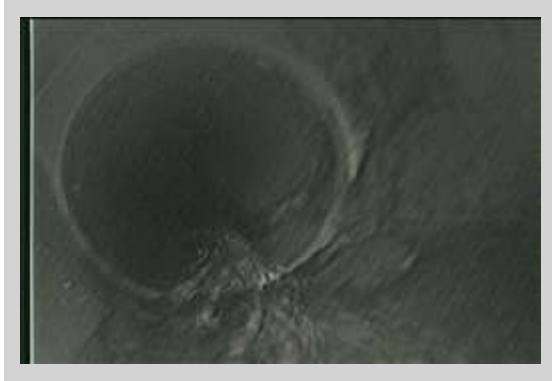
### 8 in. Circular Gravity Sewer Pipe Out @ 12 O'Clock

Infiltration: **Evidence** Pipe Seal Cond: **Cracked**
